Evaluation of arctic ice-free land sites
Kronprins Christian Land and Peary Land,
North Greenland 1960

William E. Davies
Daniel B. Krinsley

Air Force Surveys in Geophysics
No. 135

Project 7628
Task 76284

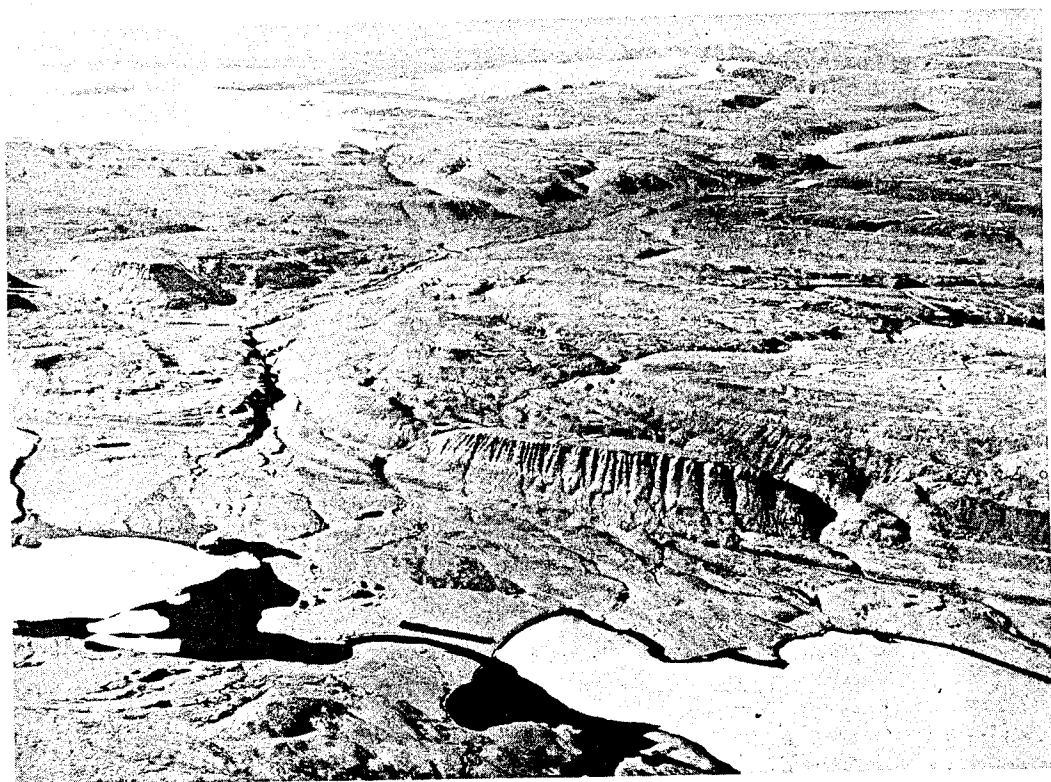
Figure 27. Slusen site, view northwest. Geodaetisk Institut (Denmark) all rights reserved.

Location -- The Slusen site is on the north side of the river channel that connects Nedre Midsommersø and Øvre Midsommersø. 82° 15'N x 33° 48'W. Altitude of site 620 ft (189 m) (Fig. 27).

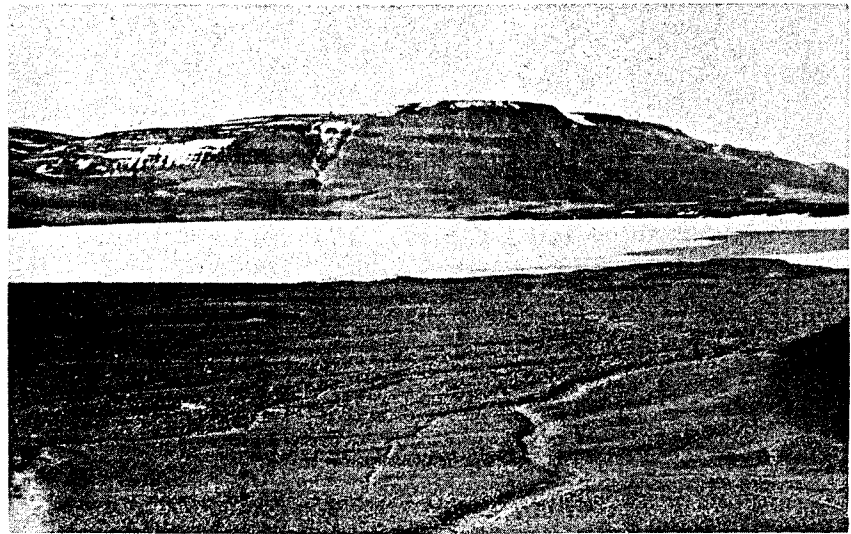
Landform -- At Slusen the river channel is bounded on the north and south by terraces. The upper broad terrace is 23 ft (7 m) above the level of Midsommersø (Fig. 28). It is 4500 ft (1371 m) long east-west and about 3000 ft (914 m) wide. To the north this terrace grades into a kame terrace that is 90 ft (27 m) above the level of the lake. This kame terrace is 750 ft (228 m) wide and ends at the base of a third terrace which is 900 ft (274 m) wide and ends on the north at an outcrop of diabase. The terrace surfaces have numerous frost mounds and polygon trenches with relief as much as 3 ft (1 m) in height.

Figure 28. View west at west end of Slusen site, 10 July 1960.

Engineering aspects -- Grading of about 40,000 cubic yards (30,600 cubic meters) would be necessary to remove microrelief features on a 3000-ft (914-m) strip. 80,000 cubic yards (61,200 cubic meters) of grading would be necessary for a 4500-ft (1371-m) runway.

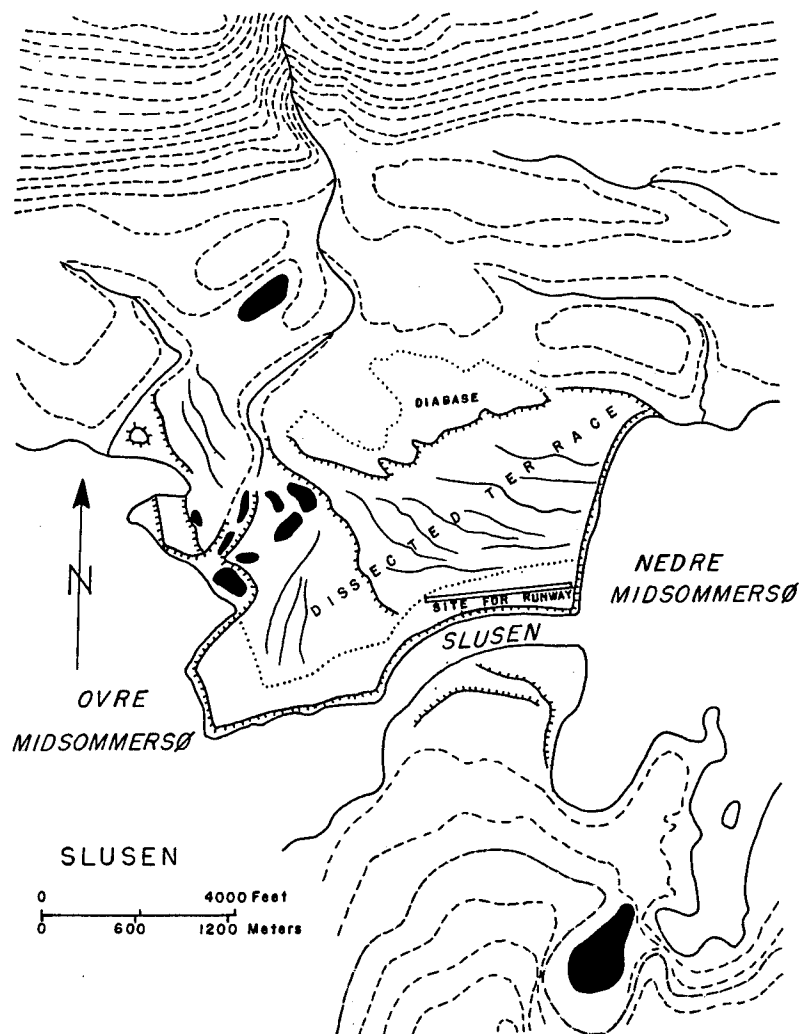
Figure 29. Map of Slusen site.

Dimensions and orientation -- The best site for an airstrip is on the 23-ft (7-m) terrace 30 to 1600 ft (10 to 183 m) from Slusen, oriented in an east-west direction. A runway 3000 ft (914 m) long could be made with minimum grading; and with moderate grading a runway 4500 ft (1371 m) long could be made (Fig. 29).

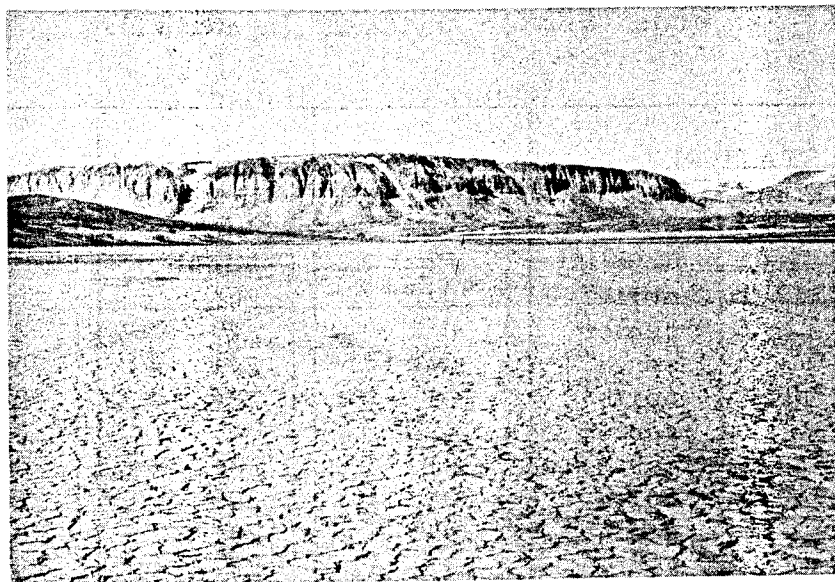
Condition of runway -- The runway at Brønlund Fjord is on the floor of a former lagoon. The soil is a hardpacked clay-silt. The runway is 5000 ft (1524 m) long, oriented N35°W. On 8 July 1960 the west half of the runway was dry and strong with soil strengths as high as 25 (CBR) 1/ The east half had several wet areas where drainage from

Figure 30. View northwest, 2000 feet (609 m) from southeast end of Brønlund Fjord site. Dark areas are wet soils. 8 July 1960.

the south crossed the site and in places where wheel ruts were made by the test aircraft (Figs. 30 and 31). In the wet areas, soil strength was very low (CBR 0 to 6). Detailed CBR readings were made along the runway at intervals of about 500 ft (152 m) (Fig. 32 and Table 2).

Conclusions -- The east half of the runway at Brønlund Fjord is not safe for use in its present condition from early June to mid-July. Shallow ditches parallel to the runway to divert drainage from the hills to the south would probably make the runway suitable for 12-month capability except for a period of a week or two in early June.

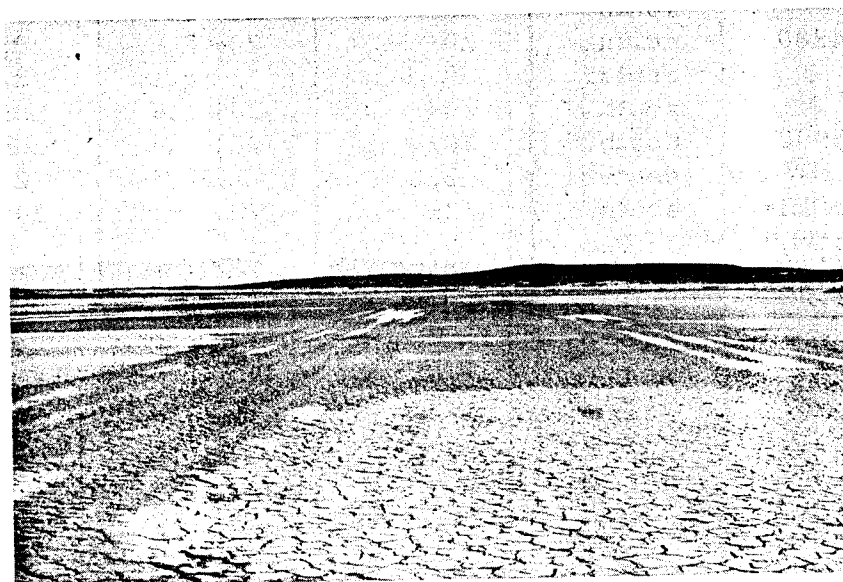
Figure 31. View southeast, 2000 feet (609 m) from southeast end of Brønlund Fjord site. Dark areas are wet soils, 8 July 1960.

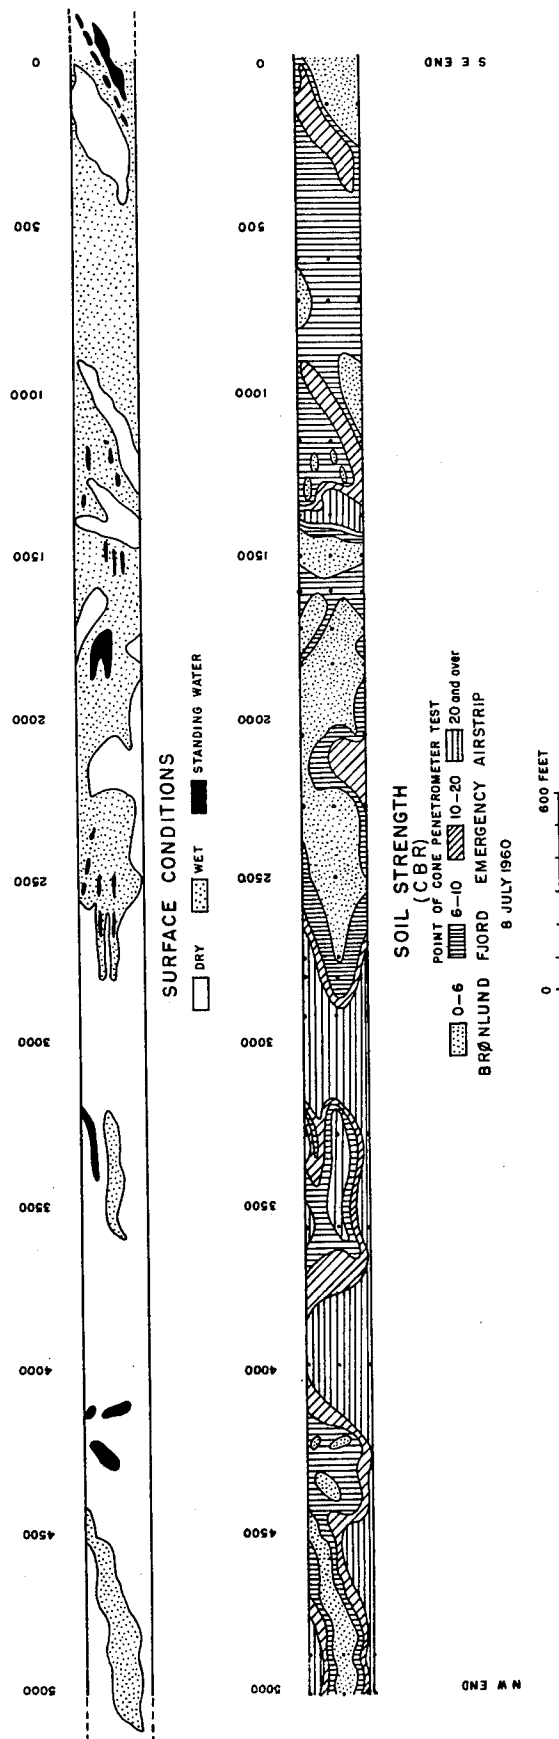
STATION 0 at SE end of airstrip	1-in depth	3-in depth	6-in depth	12-in depth
2740 ft - north	20+	20+	20+	20+
center	0	4	4	3
south	20+	20+	20+	20+
2800 north	20+	20+	20+	20+
center	4	7	3	4
south	20+	20+	20+	20+
2920 north	20+	20+	20+	20+
center	20+	20+	20+	20+
south	20+	20+	20+	20+
3280 north	20+	20+	20+	20+
center	3	3	4	3
south	20+	20+	20+	20+
3570 north	1	2.5	4	1.5
center	9	2	3	7
south	20+	20+	20+	20+
3990 north	20+	20+	20+	20+
center	20+	20+	20+	20+
south	20+	20+	20+	20+
4880 north	20+	20+	20+	20+
center	8	3	3	3
south	20+	20+	20+	20+
5000 north	20+	20+	20+	20+
(NW end center	2.5	2.5	2.5	2.5
of air- south	20+	20+	20+	20+
strip)

Figure 32. Plan of runway at Brønlund Fjord showing strength of soil and surface conditions.

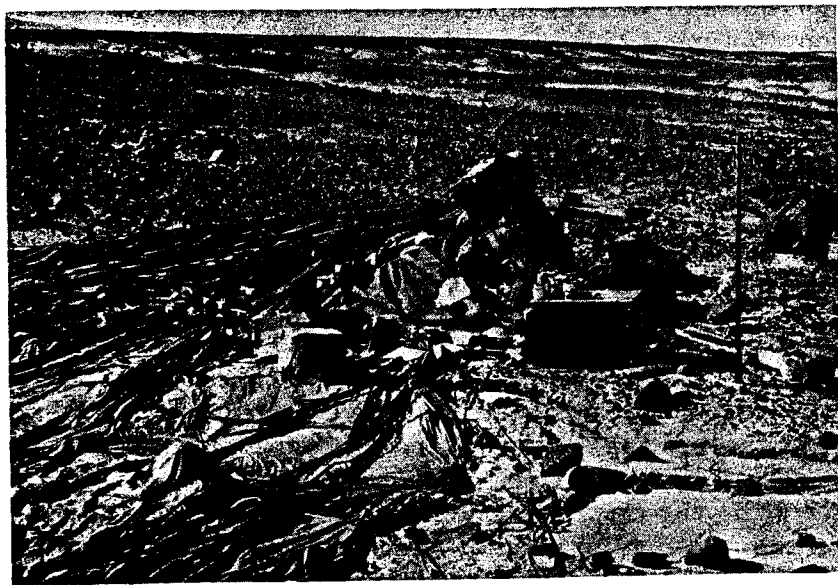
Brønlund Fjord. Sixteen pallets (67 barrels of aviation gasoline; 2 barrels of white gasoline; 3 barrels of oil; food; and equipment) were parachute-dropped on 21 June 1959. Twenty-eight barrels of aviation gasoline were damaged and the contents lost, due to unopened parachutes resulting from inadequate spacing of the trip lines. Some food was also lost because of parachutes dragging along the ground (Fig. 33), but all equipment (radio, generator) was recovered when the site was visited on the ground on 9 July 1960. All fuel parachute-dropped on 20 June 1960 was recovered on 9 July 1960.

Figure 33. Condition of airdropped material, Brønlund Fjord, 9 July 1960. Airdrop was made in 1959.

- a. Drops should not be made with a surface wind greater than 20 knots.
- b. Parachutes used in arctic areas (with strong winds) must be automatically detachable from the pallets on landing.
- c. Parachutes and pallets should be marked with both orange and white panels for either snow or land conditions. Camouflage parachutes should not be used.
